## The Control of Pinhole and Crack Defect on the Surface of Cold Heading Steel Billet

Wei Zhang<sup>1,2</sup>, Liqiang Zhang<sup>2\*</sup>, Ali Naqash<sup>2\*</sup>, Aonan Zhao<sup>2</sup>, Chaojie Zhang<sup>2</sup>

<sup>1</sup>Jiangyin China Resources Steelmaking limited company, Jiangyin, 214404, China

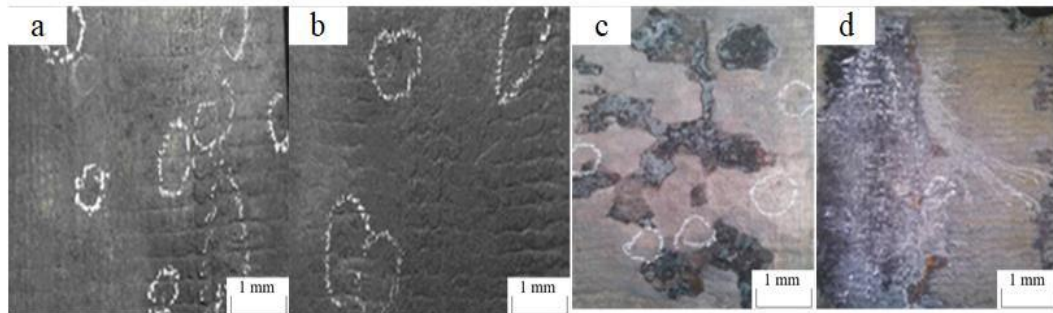
molten steel decrease to different degrees with the increase of the mould current, indicating that electromagnetic stirring in the mould can remove the contents of [O] and [N] in molten steel. The removal capacity increases with the increase of stirring current. It can be seen from the low-magnification surface in **Figs. 4a and 4b**, that the number of pinholes was significantly more at stirring current of 150A than that of 300A. Under the condition of a single controlled variable, it is indicated that the stirring current of the mould has a significant reduction effect on the formation of the pinhole in the continuous casting billet.

**Figure4.** (a) The impact of 150A on the pinhole, (b) The impact of 300A on the pinhole, (c) The mould slag of rivet steel, and (d) The Stolberg mould slag.

Through the same tundish, 6-7 flows for the mould slag of rivet steel, and 8-9 flows for Stolberg mould slag were used. The super heat, casting speed, and amount of molten steel were the same for both different mould slags. It can be seen that the gap between the two different mould slags and the pickling of pinholes on the sub-surface were more obvious. The mould slag of rivet steel has a higher surface adhesion with more studs and surface pinholes. No stuttering was found on the sub-surface of Stolberg mould slag, and only one pinhole was observed on the surface, as shown in Figs. 4c and 4d. Several experiments have been carried out on two different mould slags, showing that the number of pinholes in the Stolberg mould slag is less than that of the rivet steel slag. The average number of pinholes is reduced by 0.394 (/100 cm<sup>2</sup>), indicating that the Stolberg mould slag has superior performance in pinhole control as compared to the mould slag of rivet steel, and it

also proved that the mould slag had great effect to the control the pinholes of continuous casting billet.

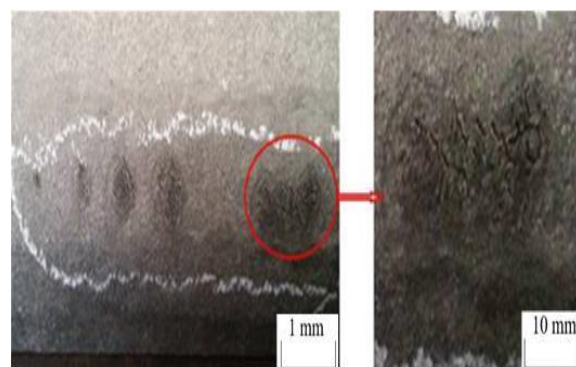
The field comparative experiments were conducted, and it was found that some of the slags had a slag ditch, and some adhered to the surface of the continuous casting billet, resulting of uneven cooling in the secondary cooling zone and surface cracks. It can be seen clearly from **Fig. 6** that un-melted mould slag particles are adhered on the surface of continuous casting billets with star-shaped cracks, indicating that the un-melted mould slag particles affect the secondary cooling effect, which leads to uneven cooling and appearance of surface cracks in the continuous casting billet.

**Figure 6.** The crack caused by mould slag.

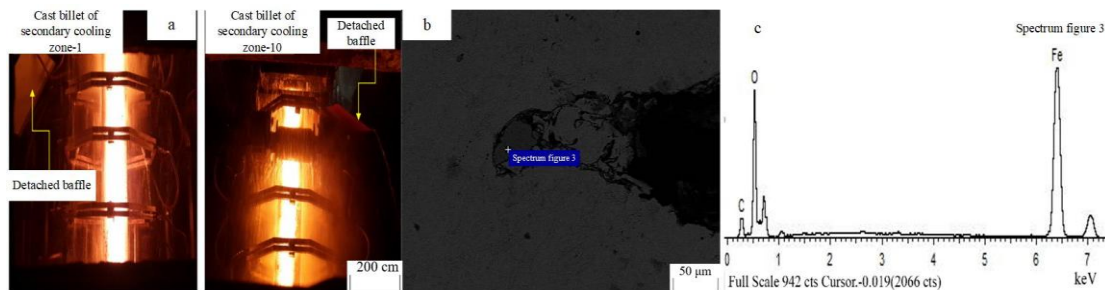
**Figure 7a** shows the casting billet in the 1<sup>st</sup> and 10<sup>th</sup> secondary cooling zones during the production process of cold heading steel containing boron10B21. The cooling water was blocked due to the falling of the baffle, resulting in uneven cooling at the surface of the casting billet. The actual specific water quantity has a certain deviation from the preset specific water quantity. The EPMA-1720 electron probe was used to analyze the composition of the slag inclusions near the surface of No.1 and 2.

Through the detection of the cast billet, it was found that there were no inclusions as shown in **Fig. 7b**, but there were different morphologies, according to the scanning composition as shown in **Fig. 7c**. The crack morphology of the casting billet and the composition analysis of the crack were detected. The composition showed that there were no trace elements such as [Cu] and [Cr]. The [S] and [P] contents did not aggregate,

and no inclusions were found. The phenomenon indicates that the crack of the casting billet is not at the meniscus of the mould, but there is a clear decarburization layer, indicating that the temperature at which the crack occurs in the casting billet is relatively high, and should appear in the first part of the secondary cooling zone. After the secondary cooling zone, the cracks continue to grow up.

**Figure 7.** (a) Secondary cooling conditions during the production process of cold heading steel containing boron 10B21, (b) Inclusions morphology, and (c) Energy spectrum.

The [S] and [P] contents of molten steel were controlled below 0.005, and 0.020 respectively. In the straightening section, the billet was avoided to the brittle zone of low-temperature and purified the water quality of the secondary cooling zone. Meanwhile, the number of ladle

casting furnaces was reduced up to or less than 18 heats, to avoid the blockage of the secondary cooling nozzle and other abnormal conditions.

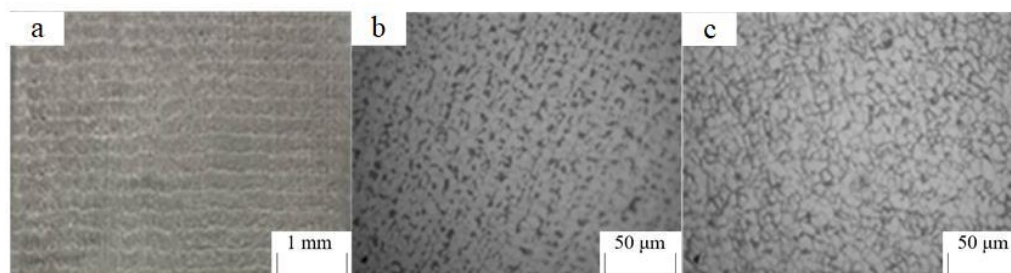
It can be seen from Table 3, that the defects of casting billets were greatly reduced before and after the optimization process, and the process rectification also improved the quality rate of rolling material. After optimization, pinholes were hardly seen on the surface of casting billets. The samples of 50 different billets were taken and only one billet was found to have one pinhole.

**Figure 8.** Surface morphology and low-magnification structure of continuous casting billet, (a) Optimized slab surface, (b) Picture of 00514 metallographic structures (×500), (c) Picture of 00516 metallographic structure (×500).

The microstructure and grain size of 10B21 steel wire rod after optimization is shown in **Fig. 8**. It

can be seen from the figure that the average grain size is above 8 grades, the crystal grains

are fine, there is almost no decarburization layer, the metallographic microstructure is ferrite and pearlite, and the product has excellent internal quality. The performance experiments of 1/2 and 1/3 cold jacking by sampling the wire rod were carried out as shown in table 4. It was found that the quality rate of the wire rod has good results by cold forging experiment, and it was improved after the optimization process.
