## The Control of Pinhole and Crack Defect on the Surface of Cold Heading Steel Billet

Wei Zhang<sup>1,2</sup>, Liqiang Zhang<sup>2\*</sup>, Ali Naqash<sup>2\*</sup>, Aonan Zhao<sup>2</sup>, Chaojie Zhang<sup>2</sup>

<sup>1</sup>Jiangyin China Resources Steelmaking limited company, Jiangyin, 214404, China

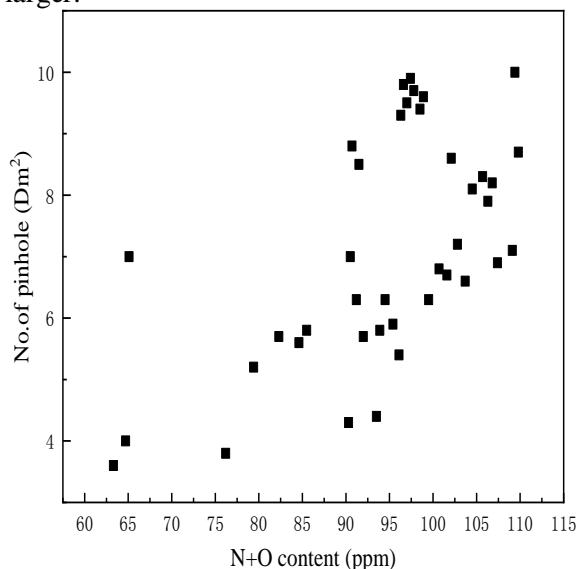
Figure 2. Relationship between gas contents and pinhole density.

continuous casting billets corresponding to oxygen and nitrogen contents were compared in the production process of cold heading steel 10B21, as shown in Fig. 2. When the sum of oxygen and nitrogen contents was less than 80 ppm, the pinholes of continuous casting billets were less likely to appear.

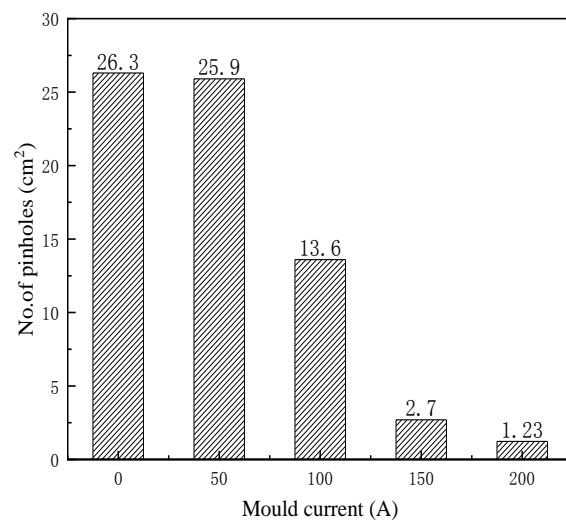
There is a great difference in the occurrence probability of pinholes between electromagnetic stirred continuous casting billets and those without electromagnetic stirring at the end. The oxygen and nitrogen in the molten steel exist in the form of a compound, and the molten steel rotates under the action of the mould electromagnetic stirring. The nitride and oxidized inclusions have the kinetic conditions of floating. Therefore, the inclusions of [O] and [N] float under the action of electromagnetic stirring.

Figure 3. Effect of electromagnetic stirring on pinholes.

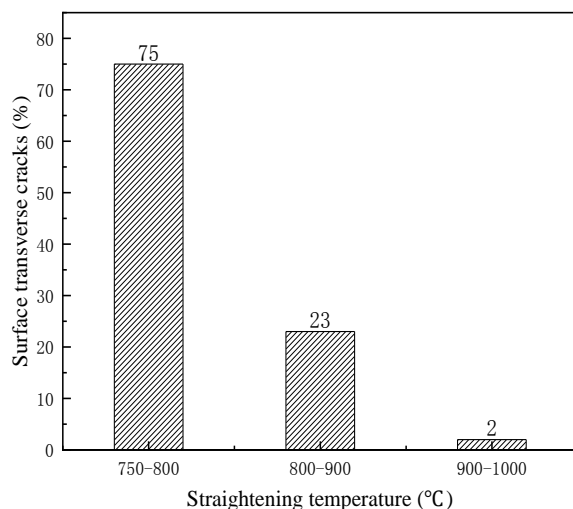
**Figure 5.** Relationship between straightening temperature and percentage of transverse crack.

experimental study of thermoplastic properties of continuous casting billets at high temperature. In the middle of this century, European IRSIDs, oral Gleeble, and others started to research on the high-temperature mechanical properties of continuous casting billets by the means of thermal simulation experiments. They concluded that continuous casting billet at 950-1350 °C, had a large shrinkage section and good plasticity [13-15]. Statistics on the straightening temperature (see figure 5) show that when the straightening temperature is lower than 900 °C, the occurrence probability of transverse cracks on the surface of continuous casting billet increases significantly.
